Manhole Inspection Summary

Manhole # S13GG1015MH

Insp Date: **6/13/07 4:40 PM**

Location Address: **SIDE- 2669 PARK HEIGHTS TERR** Cross Street: **QUANTICO AVE**

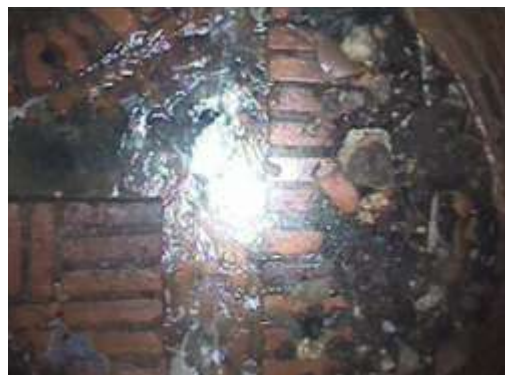
Top View

DEBRIS ON BENCH

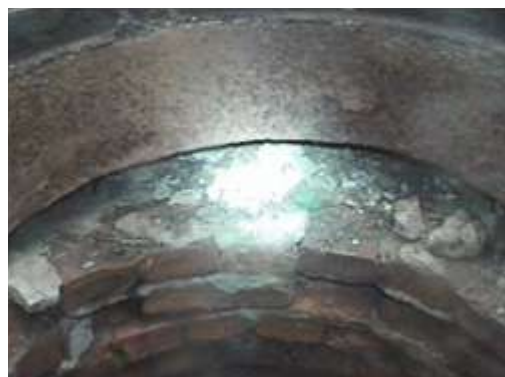
Defect 2

Condition: ☐ Sound ☐ Cracked ☐ Root Intrusion ☒ **Loose Brick** ☒ **Deteriorated**

DETERIORATED AND LOOSE BRICKS OF CHIMNEY ADJ.

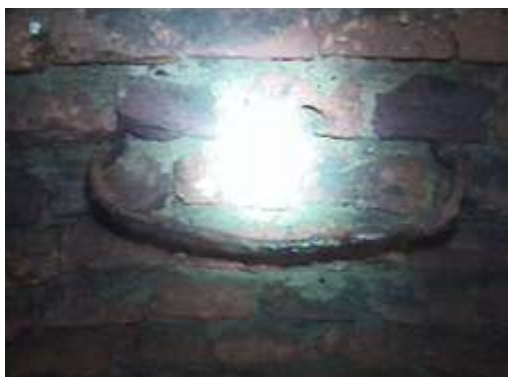
Defect 1

Steps Count: **1** Missing: **0** ☒ **Corroded**

CORRODED RUNG

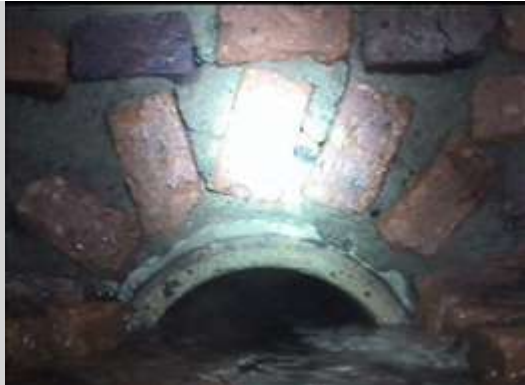
12 O'Clock Outflow

8 in. Circular Gravity Sewer
Pipe Out @ 12 O'Clock

Pipe Height: (in.) Direct
Pipe Material: **Clay** ☐ Pipe Lined
Invert Depth: **5.61** (ft.) Flow Characteristics: **Fast**
Deposits: ☐ None ☐ Mud ☐ Sludge ☒ **Debris** ☐ Grease
Silt Depth: **0.5** (in.) Deposits Extent: **Light**
Infiltration: **None** Pipe Seal Cond: **Sound**

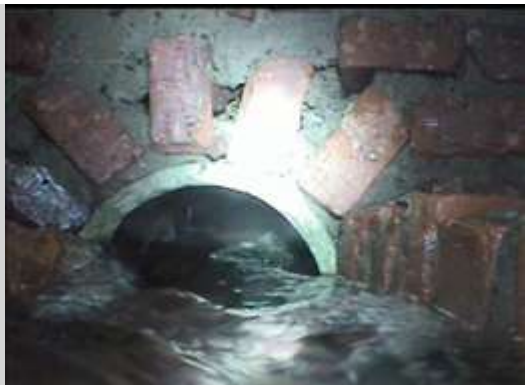
6 O'Clock Inflow

8 in. Circular Gravity Sewer
Pipe In @ 6 O'Clock

Pipe Height: (in.) Direct
Pipe Material: **Clay** ☐ Pipe Lined
Invert Depth: **5.58** (ft.) Flow Characteristics: **Fast**
Deposits: ☐ None ☐ Mud ☐ Sludge ☒ **Debris** ☐ Grease
Silt Depth: **1** (in.) Deposits Extent: **Light**
Infiltration: **None** Pipe Seal Cond: **Sound**

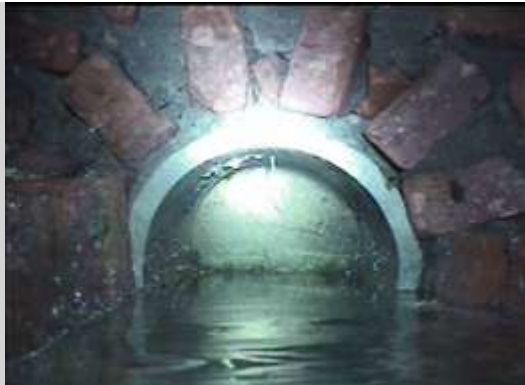
9 O'Clock Inflow

8 in. Circular Gravity Sewer

Pipe In @ 9 O'Clock

Connects To: **Stub connection / abandoned**
